Testing and Assembling of the 20-inch PMTs for the JUNO Experiment

On behalf of JUNO collaboration

2023-09-05

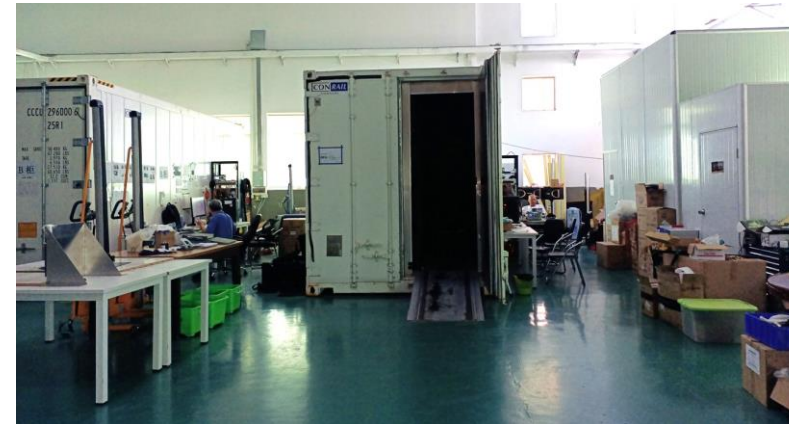
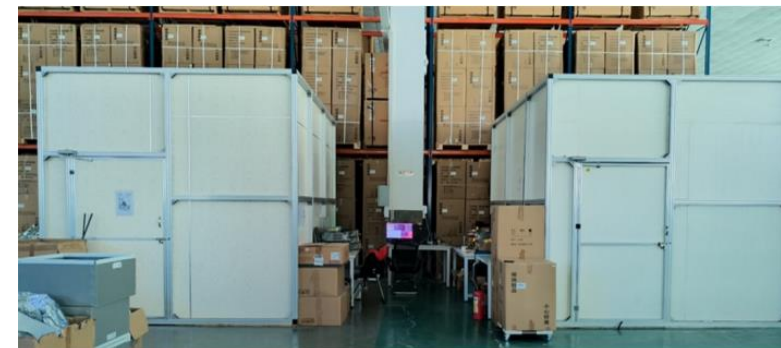
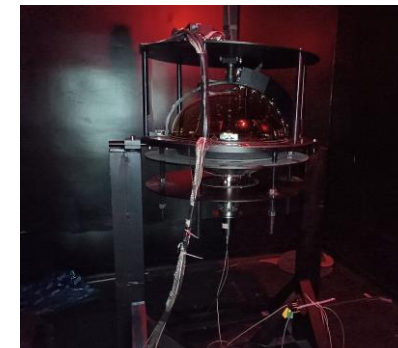
1.2 Bare PMT test: Container PMT mass test system

- Measurement and classification procedure for PMTs with the container and scanning station systems

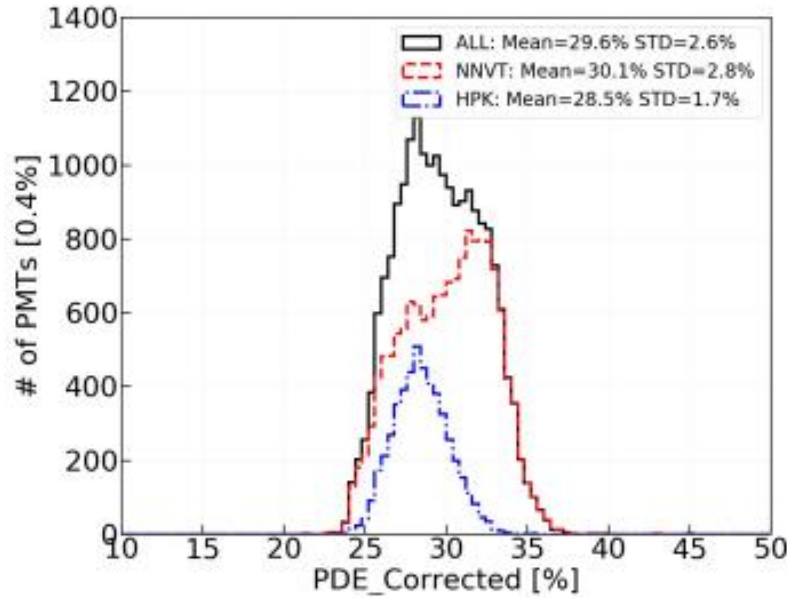
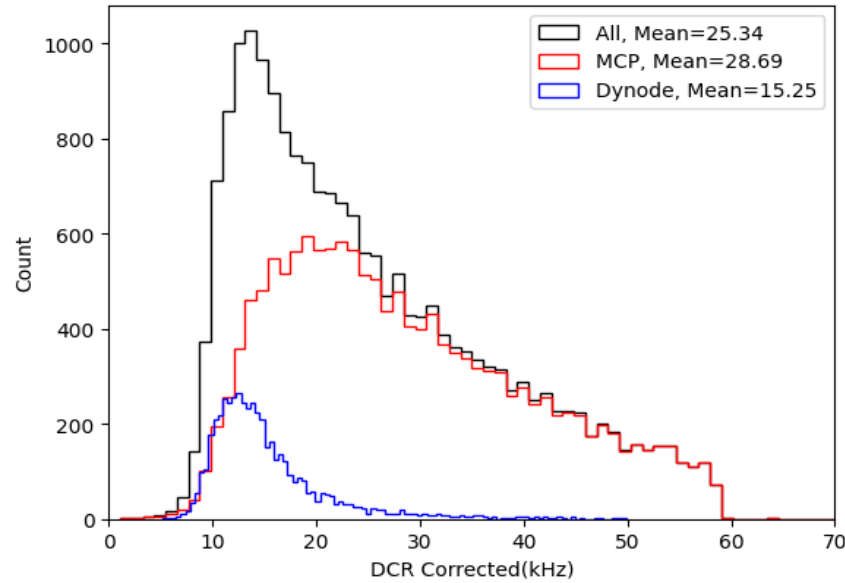
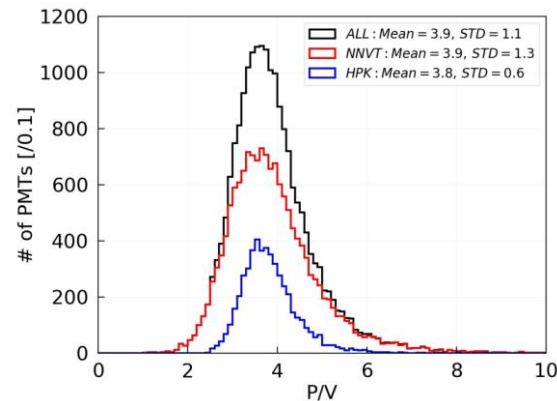
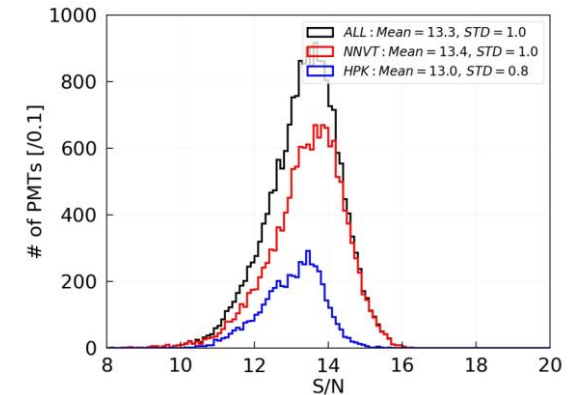
1.2 Bare PMT test: Results

Parameters	HPK	NNVT
HV(V)	1863	1736
Gain	1.00E+07	1.03E+07
PDE(%)	28.5	30.1
DCR(%)	15.3	28.7
Resolution(%)	27.9	33.2
P/V	3.8	3.9
S/N	13.0	13.4
TTS(ns)	6.3	9.7

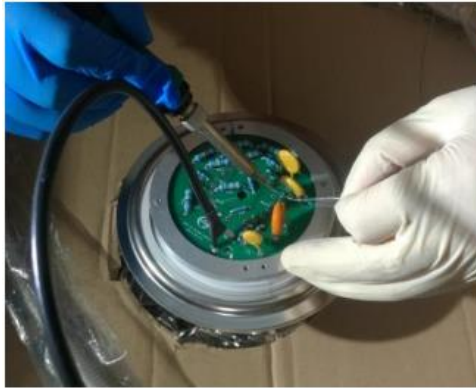
Base soldering to PMT

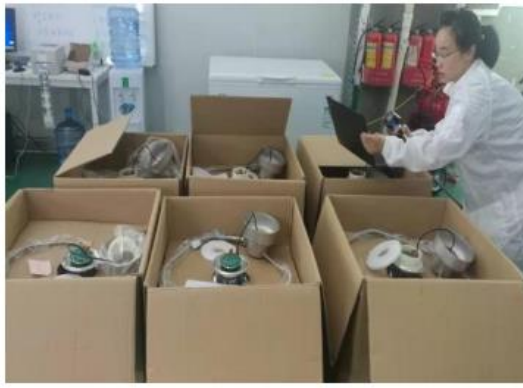
Soldering quality check

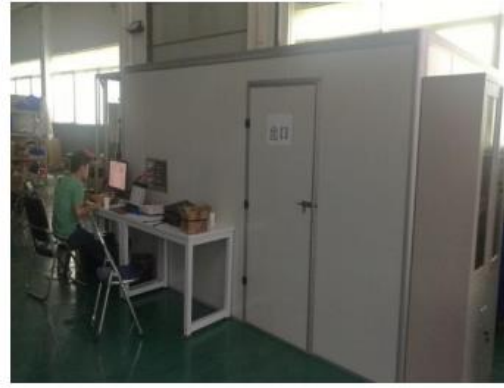
Test after soldering

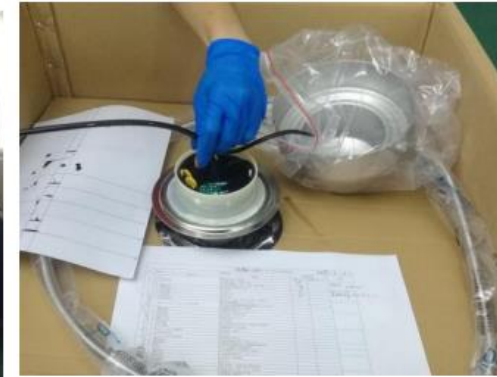
Sealing of base

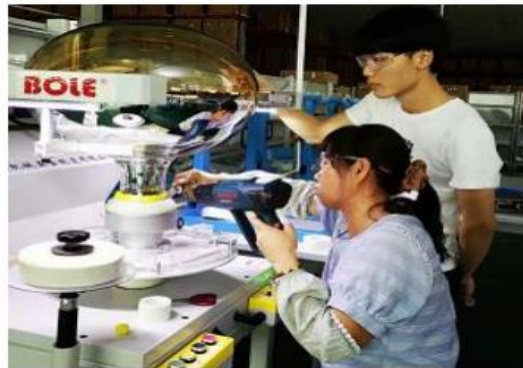
Butyl tape wrapping

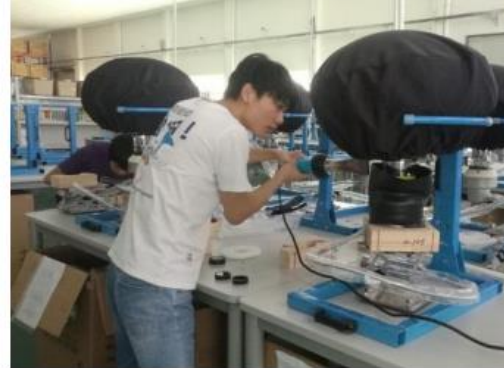
Shrinkable tube heating

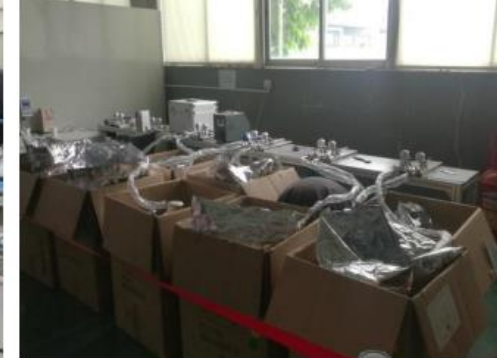
Leak test

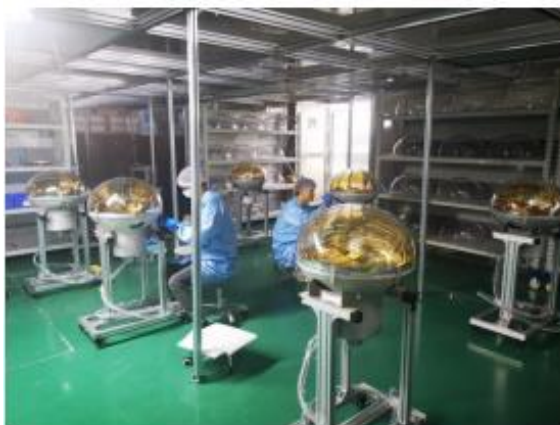
Cover assembling

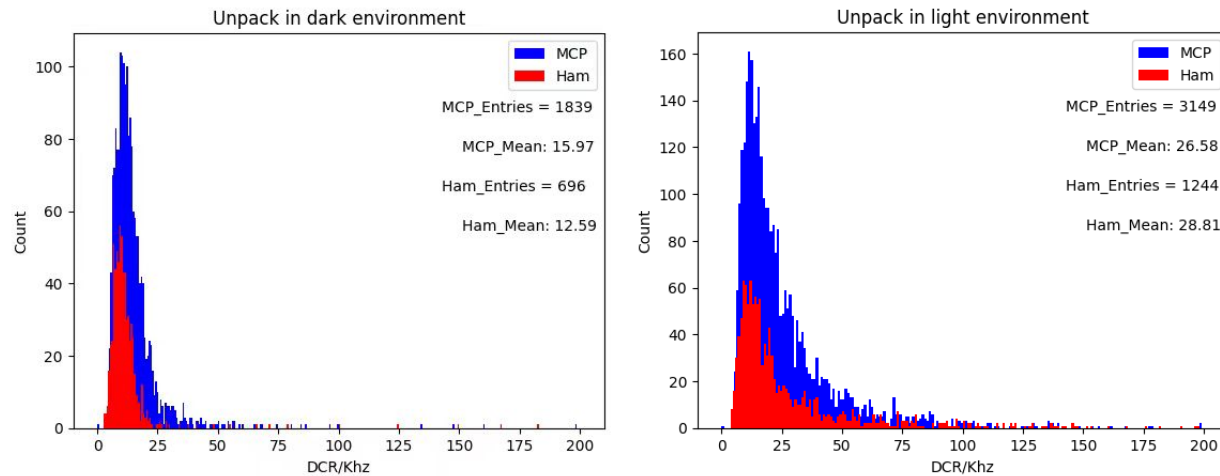
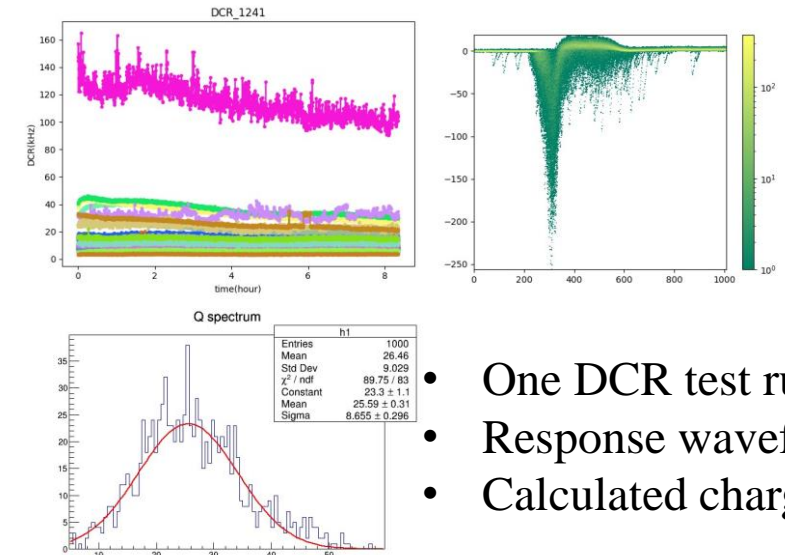
2.2 PMT Test in SAB

- One DCR test run
- Response waveform of light
- Calculated charge distribution

Unpack PMT in dark or light environment, DCR shows different.

Dark	Entries	DCR (kHz)	Light	Entries	DCR (kHz)
MCP	1839	15.97	MCP	3149	26.58
Ham	696	12.59	Ham	1244	28.81

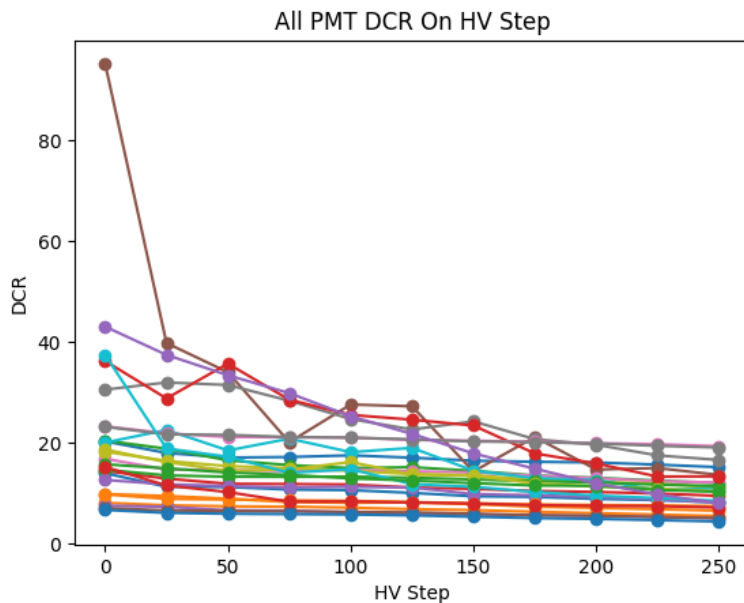
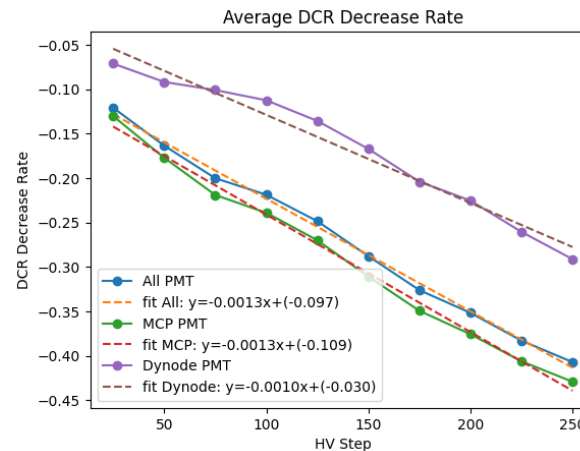
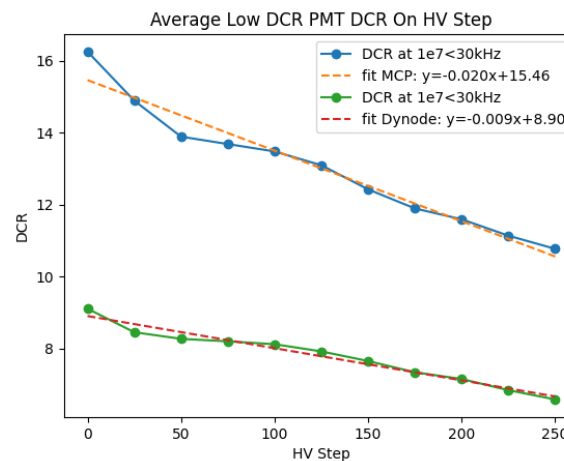
2.3 PMT DCR Study in SAB: DCR HV-scan Test

Up Pictures:
HV decrease from
HV@1E7 to
HV@1E7 -250V
Step=25V

For PMTs with low DCR,
DCR of MCP PMTs decreases about
1 kHz every **50V**;

DCR of Dynode PMTs decreases about
0.5 kHz every **50V**;

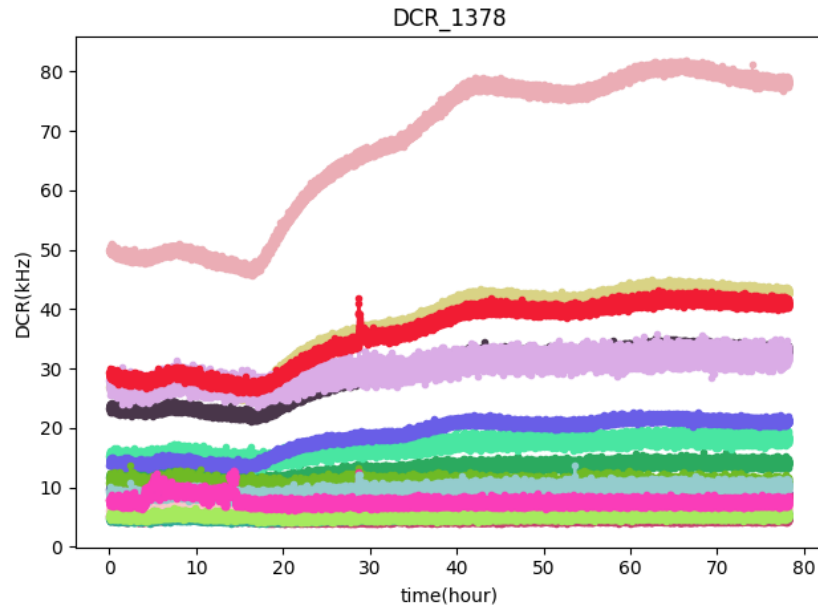
2.3 PMT DCR Study in SAB: DCR Temperature Test

- The DCR of most of PMTs is not sensitive to temperature.
- Mean time of lowest DCR is 220 minute later lowest temperature.
- Keeping temperature at a low level is benefit to big detector performance.

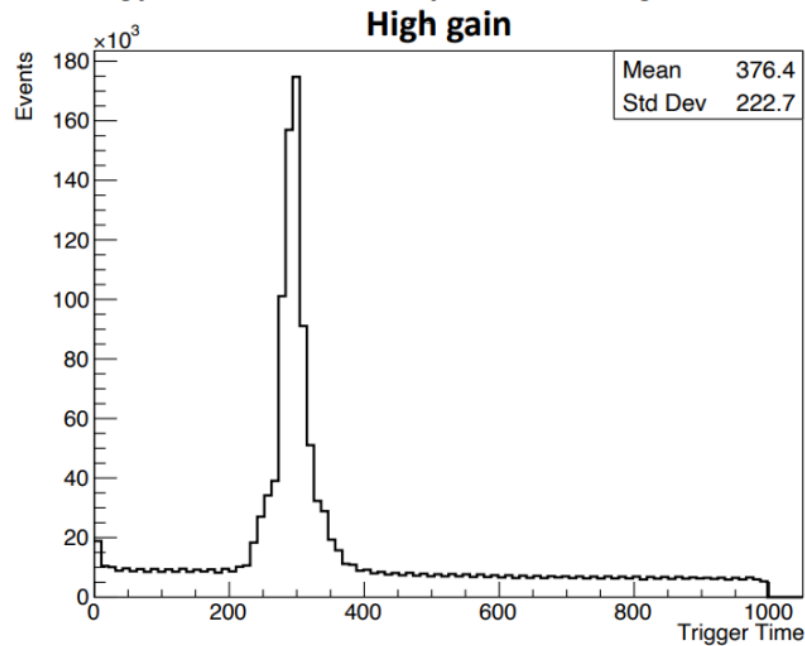
Hit time distribution of BEC nhit events

- Understanding PMT hit patterns ongoing.
- Light leakage could due to holes near the connection bars of SS structure

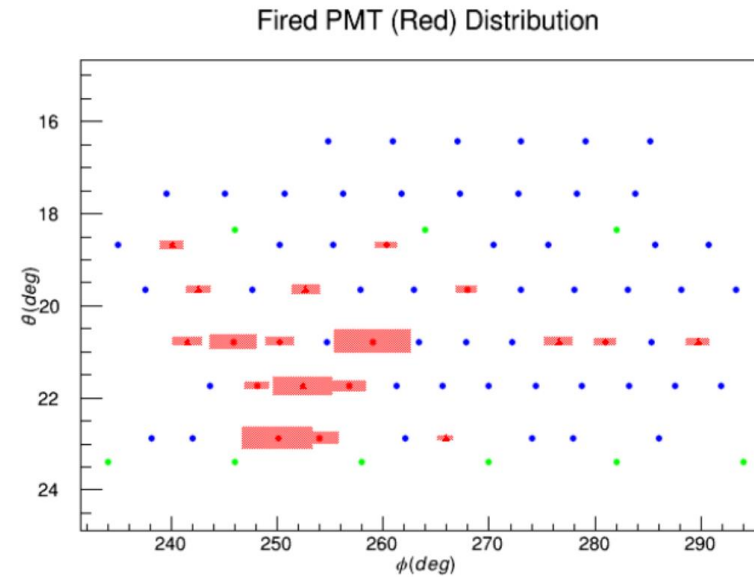
Hit pattern
